Effect of Humidity and Temperature on Composite Plates With Different Fiber Orientations

Gurbet Örcen^{1*}, Engin Koyun²

In this study, the effect of humidity and temperature on glass fiber reinforced epoxy composite plates with different fiber reinforcement angles and different widths were experimentally investigated. For this purpose, composite plates with fiber reinforcement angles of $[0^\circ]_8$ and $[45^\circ/-45^\circ/0^\circ/90^\circ]_8$ were prepared in 25 mm and 30 mm dimensions and kept in hot water at 40 °C, 60 °C and 80 °C for 15, 30 and 45 days. At the end of the duration, the moisture absorption rates and strengths of the specimens were obtained. The obtained data were compared among themselves and with that of dry specimens. In addition, the morphologies of the specimens were visualized with the help of Scanning Electron Microscope (SEM) and the effects of humidity and temperature on failure behavior were examined. It was determined that the strength of the $[45^\circ/-45^\circ/0^\circ/90^\circ]_8$ fiber orientations specimens was lower than the strength values obtained from the $[0^\circ]_8$ fiber orientations specimens. It has been determined that when the wait

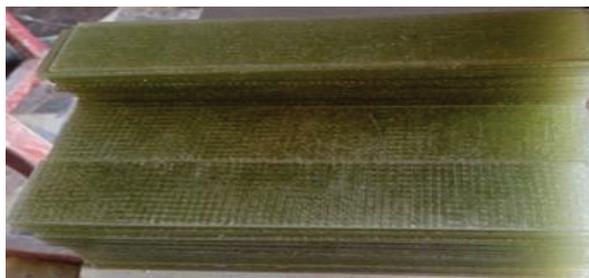
Figure 1. Specimen Preparation

and Trade Ltd. Co. Composite plates are produced with a thickness of 2 mm (t). The length (L) of the composite plates with both fiber orientations was taken as 175 mm and their widths were prepared as (w) 30 mm and (w) 25 mm (Figure 1). Three specimens were prepared from each geometry.

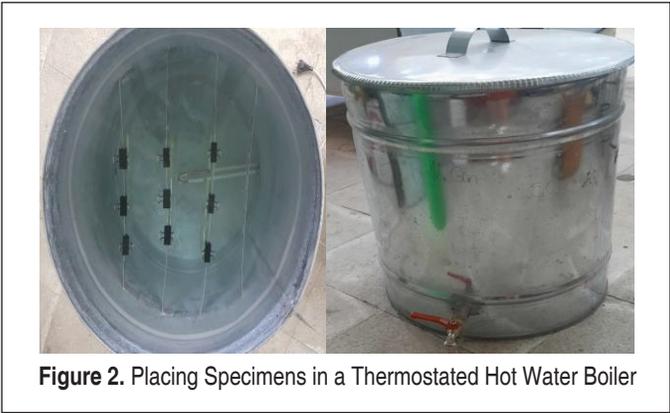
Figure 2. Placing Specimens in a Thermostated Hot Water Boiler

In addition, specimens were formed by gluing additional pieces of the same material using adhesive to prevent the formation of stress concentrations in the compression regions during in the tensile test. Composite specimens with both geometric dimensions and fiber orientations were placed in closed boilers filled with hot water in which thermostats adjusted to 40 °C, 60 °C, and 80 °C. Additional hangers were made for the placement of the specimens in the boilers (Figure 2). They were kept at each temperature for 15, 30, and 45 days.

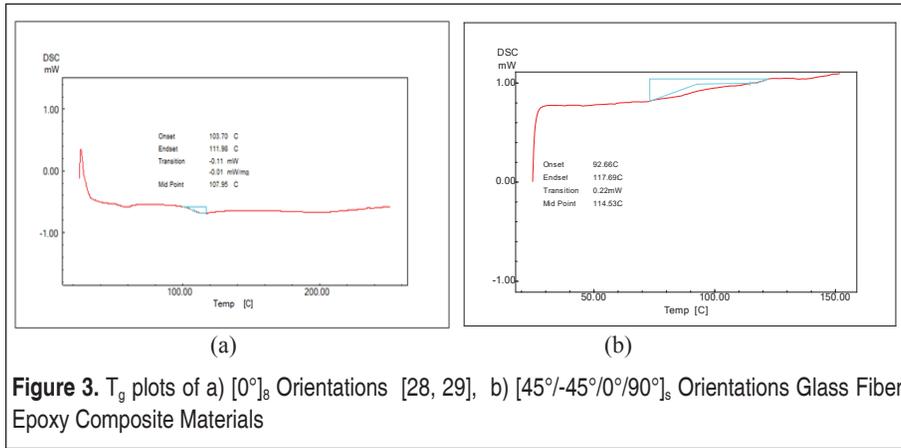
properties of these materials may vary at different temperatures, -especially below or above the glass transition temperature. Therefore, the glass transition temperatures (T_g) of the plates in both fiber orientations were determined by Differential Scanning Calorimetry (DSC) analysis in order to better understand the effects of humidity and temperature. This analysis was carried out with Shimadzu DSC-60 type device by increasing the temperature by 10 °C per minute. As a result of DSC analysis, T_g of glass fiber reinforced epoxy composite materials with $[0^\circ]_s$ and $[45^\circ/-45^\circ/0^\circ/90^\circ]_s$ fiber reinforcements were 107.95 °C, 114.53 °C respectively (Figure 3).

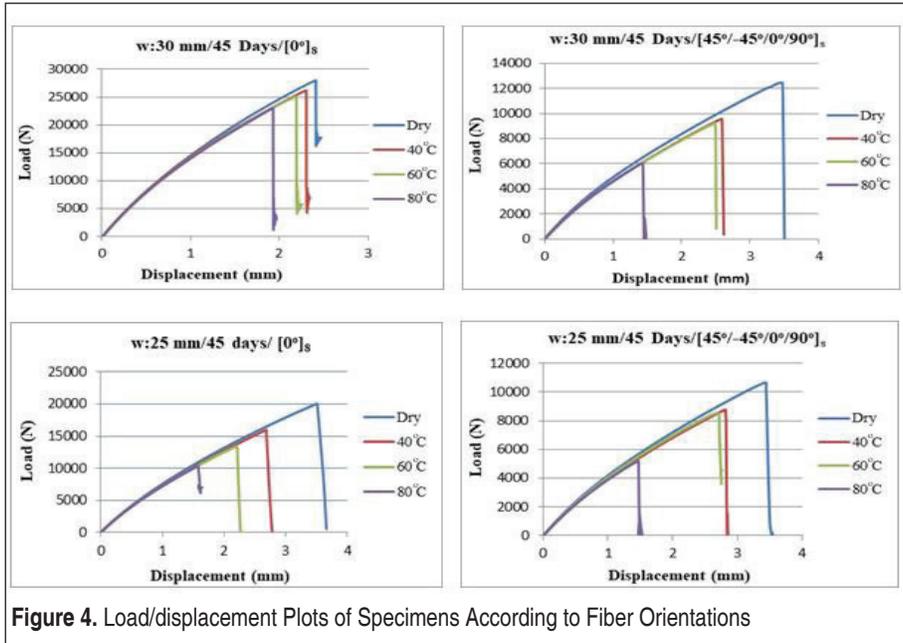
Figure 4. Load/displacement Plots of Specimens According to Fiber Orientations

The values obtained as a result of the tensile test of glass fiber reinforced composite specimens and the standard deviation rates of these values are given in Table 2. Load-displacement plots obtained according to fiber orientations and specimen width are given in Figure 4 over the maximum waiting time (45 days). At the same time, the waiting times of composite specimens in hot water - with regard to their fiber orientations - and the load values obtained at the end of these periods are given in Figure 5 and Figure 6 comparatively.

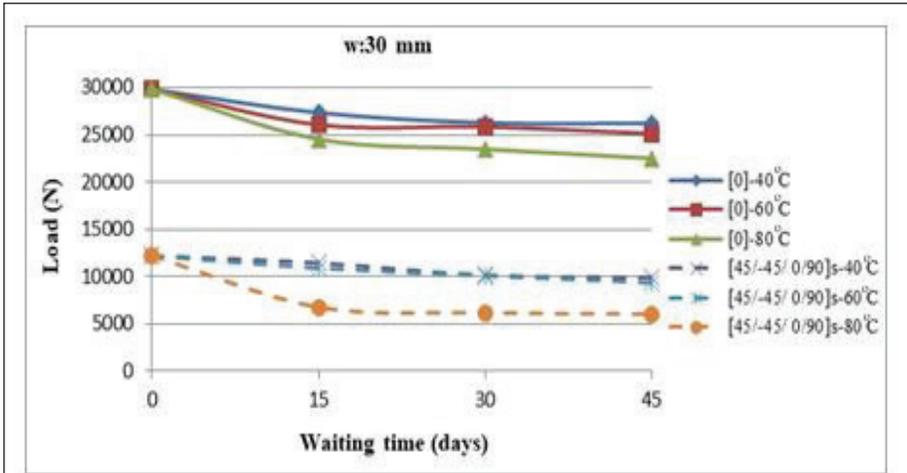
Figure 5. Waiting Time and Load Relationship Graph

45°/0°/90°_s orientations are kept at 80 °C for 45 days is found to be lower respectively by 14.14% and 38.38% compared to the failure loads values obtained from the specimens kept at 40 °C for 45 days (Table 2, Figure 5). Similarly, for the specimens with [0°]_s and [45°/-45°/0°/90°]_s orientations (30 mm); It was determined that the failure load values obtained when kept at 60 °C for 45 days decreased by 15.74% and 17.37%, respectively, compared to the failure load values obtained from the dry specimens (Table 2, Figure 5).

the material strength tends to decrease significantly due to the plasticization of the epoxy [18]. In our study, the strength values of the composites with $[0^{\circ}]_8$ and $[45^{\circ}/-45^{\circ}/0^{\circ}/90^{\circ}]_s$ orientations decreased depending on the waiting time in hot water and the amount of moisture absorbed during these periods. Specimens with both orientations and widths presented a significant decrease at 80 °C (Table 2, Figure 5 and Figure 6).

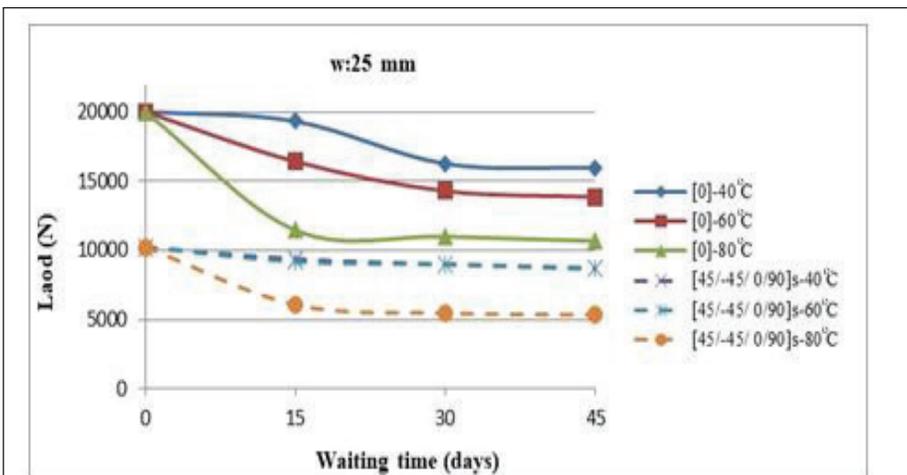
Figure 6. Waiting Time and Load Relationship Graph

The failure load values obtained when the 25 mm wide specimens with the [0°]_s and [45°/-45°/0°/90°]_s fiber orientations are kept at 80 °C for 45 days is found to be decreased respectively by 33.06% and 38.72% compared to that of specimens that were kept at 40 °C for 45 days. (Table 2, Figure 6). For the specimens with [0°]_s and [45°/-45°/0°/90°]_s orientations and 25 mm width; It was determined that the failure load values obtained when kept at 60 °C for 45 days decreased by 30.73% and 15.59%, respectively, compared to the failure load values obtained from the dry specimens. (Table 2, Figure 6).

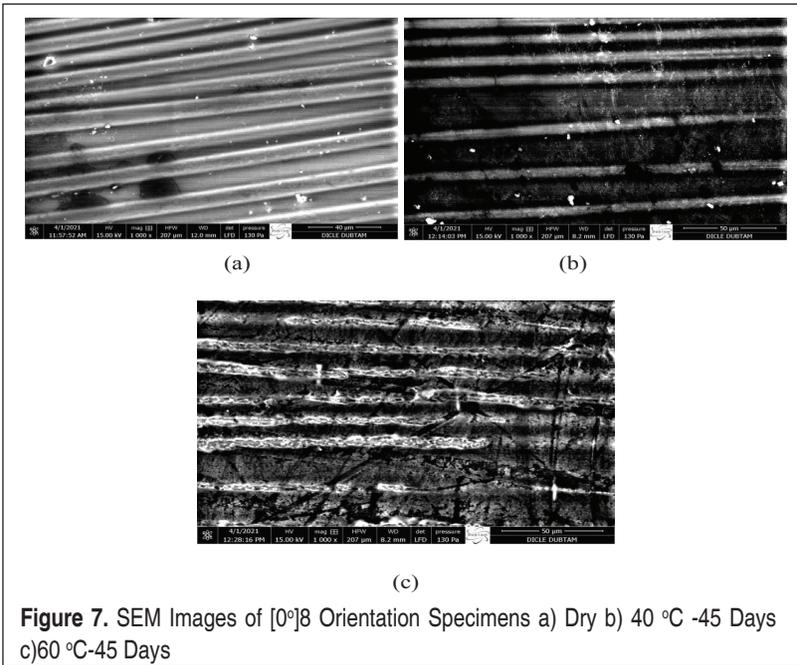
Figure 7 (b) shows SEM images of $[0^\circ]_8$ orientation specimens with 0.91% moisture absorption and 26214.5 N failure load when kept at 40 °C for 45 days. In Figure 7 (c), SEM images of $[0^\circ]_8$ orientation specimens with 0.79% moisture absorption and 25120.5 N failure load when kept at 60 °C are shown. In Figure 8 (b), SEM images of specimens with 9891.45 N failure load and $[45^\circ/-45^\circ/0^\circ/90^\circ]_8$ orientation that presents 2.08% moisture absorption when kept at 40 °C for 45 days are presented. In Figure 8 (c), SEM images of specimen - with the same orientation - that displayed 9366.08 N failure load due to the 1.41% moisture absorption rate when kept at 60 °C are presented.

In Figure 7 (b, c) and Figure 8 (b, c), deterioration stages that occur in the matrix or at the interface, depending on the temperature and humidity changes, are presented. This deterioration is more evident, especially for specimens with higher moisture ab-

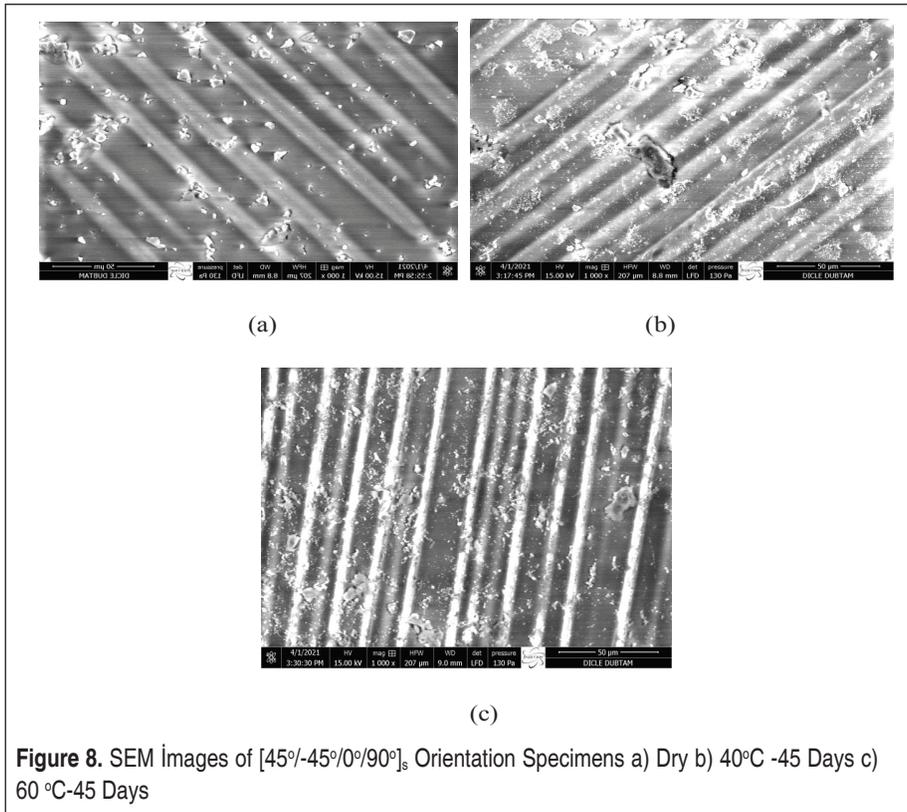
sorption rates and $[45^\circ/-45^\circ/0^\circ/90^\circ]_s$ orientation, in the SEM images and the images are presented in Figure 8 (b, c).

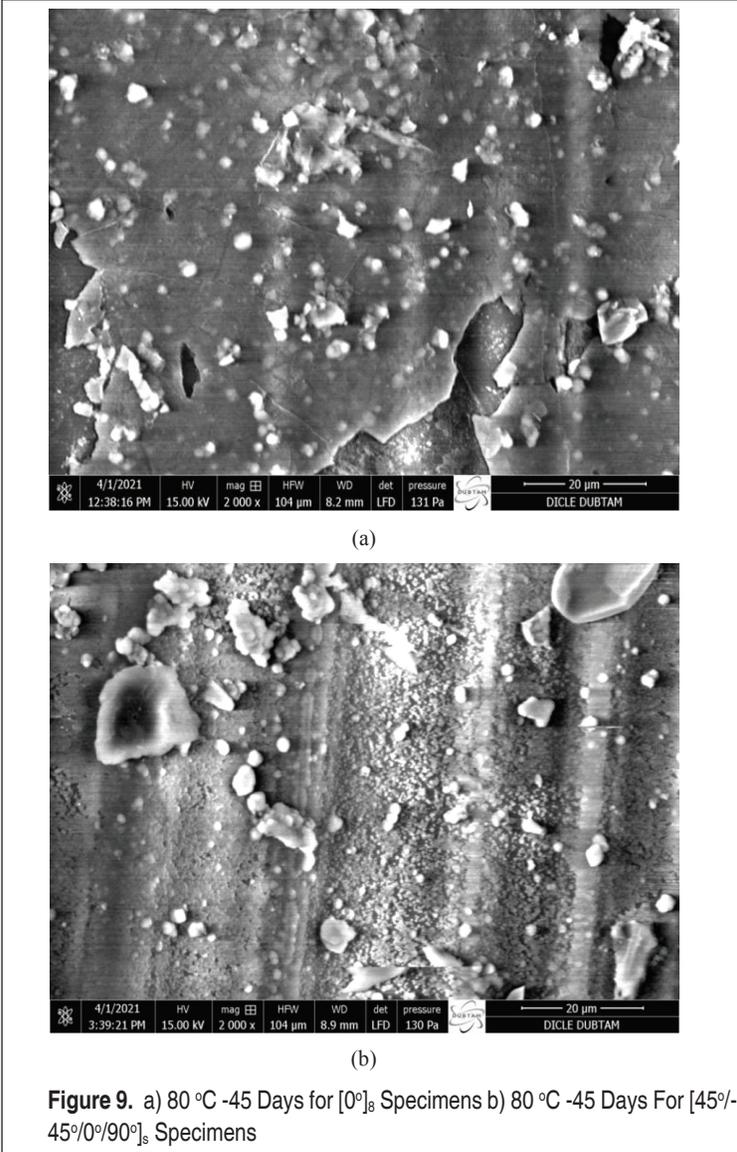
This clearly reveals that the low strengths are the result of humidity, and temperature, hence, humidity and temperature effects are more evident for the specimens that are kept at 80 °C for 45 days. In particular, it was observed that the deterioration in these specimens was clearer (Figure 9). Therefore, SEM images- with 2000x magnitude - of specimens in the given range and with two different fiber orientations are displayed in Figure 9 (a,b).

In Figure 9 (a), SEM images of the $[0^\circ]_s$ orientation specimen with a failure load of 22506.5 N and a moisture absorption rate of 1.47% at 80 °C are presented. In Figure 9 (b), SEM images of the $[45^\circ/-45^\circ/0^\circ/90^\circ]_s$ orientation specimen with 3.8% moisture absorption rate and 6044.7 N failure load at 80 °C is presented. In Figure 9 (a)' and Figure 9 (b), it is seen that particles in the form of fractures/cracks are formed in the matrix material along with the interfacial deterioration as a result of moisture rates. It is observed that the effects of humidity are especially greater on the resin, a new interface is formed and the resin incurred losses due to fractures (Figure 9a). It was

determined that the interface formed in Figure 9 (b) deteriorated more due to moisture absorption. These interface defects caused by moisture absorption weakened the stress transfer from the matrix to the fibers, hence, resulted a reduction in tensile strength [19].
